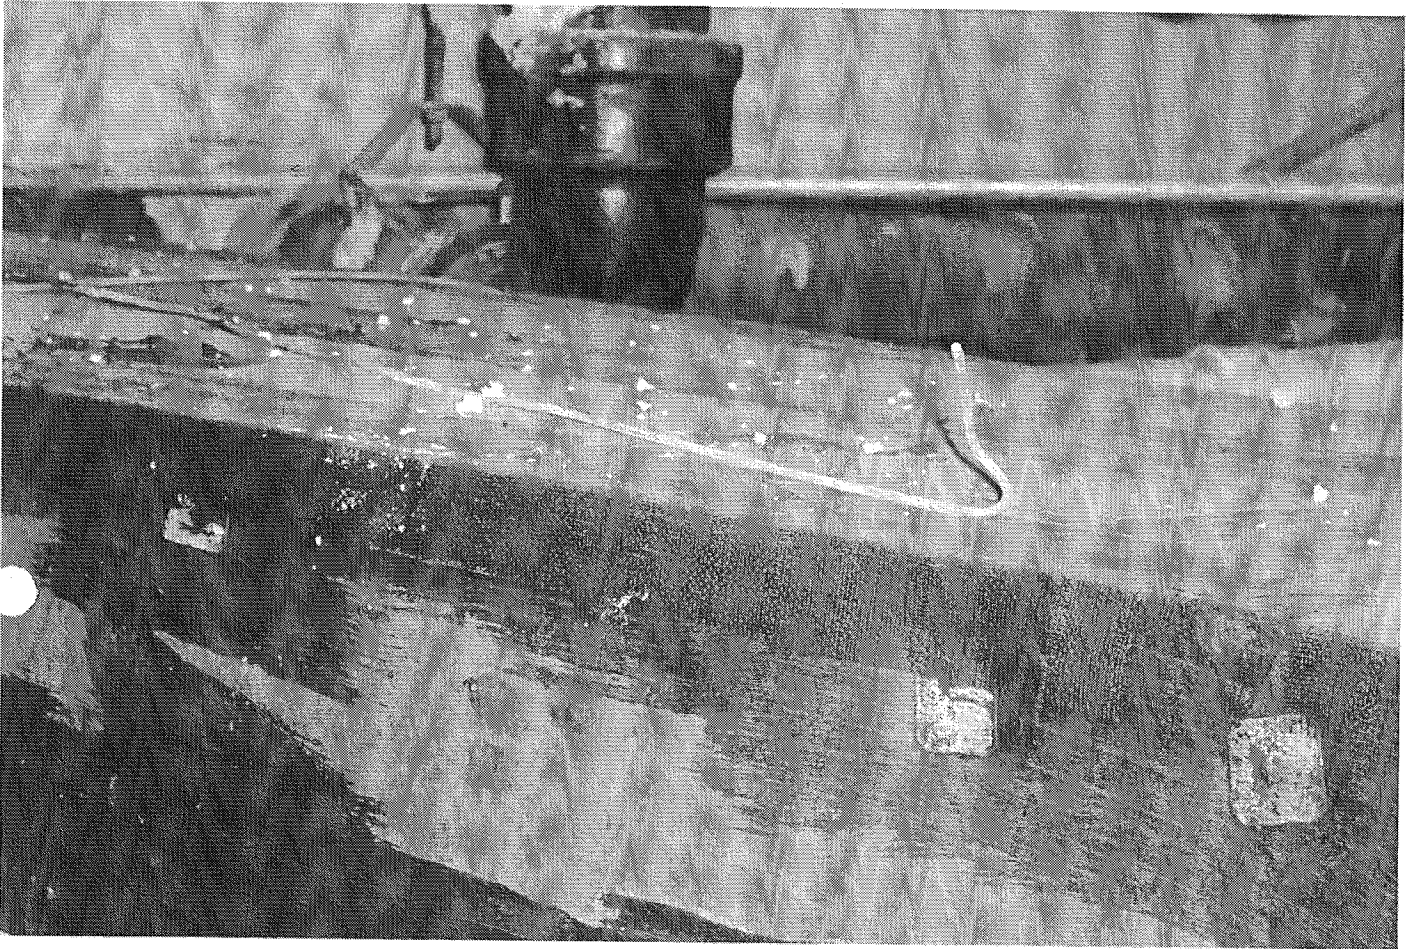
35. B Floor West Mech Rm - General view of fireproofing debris on top of HVAC duct above suspended ceiling

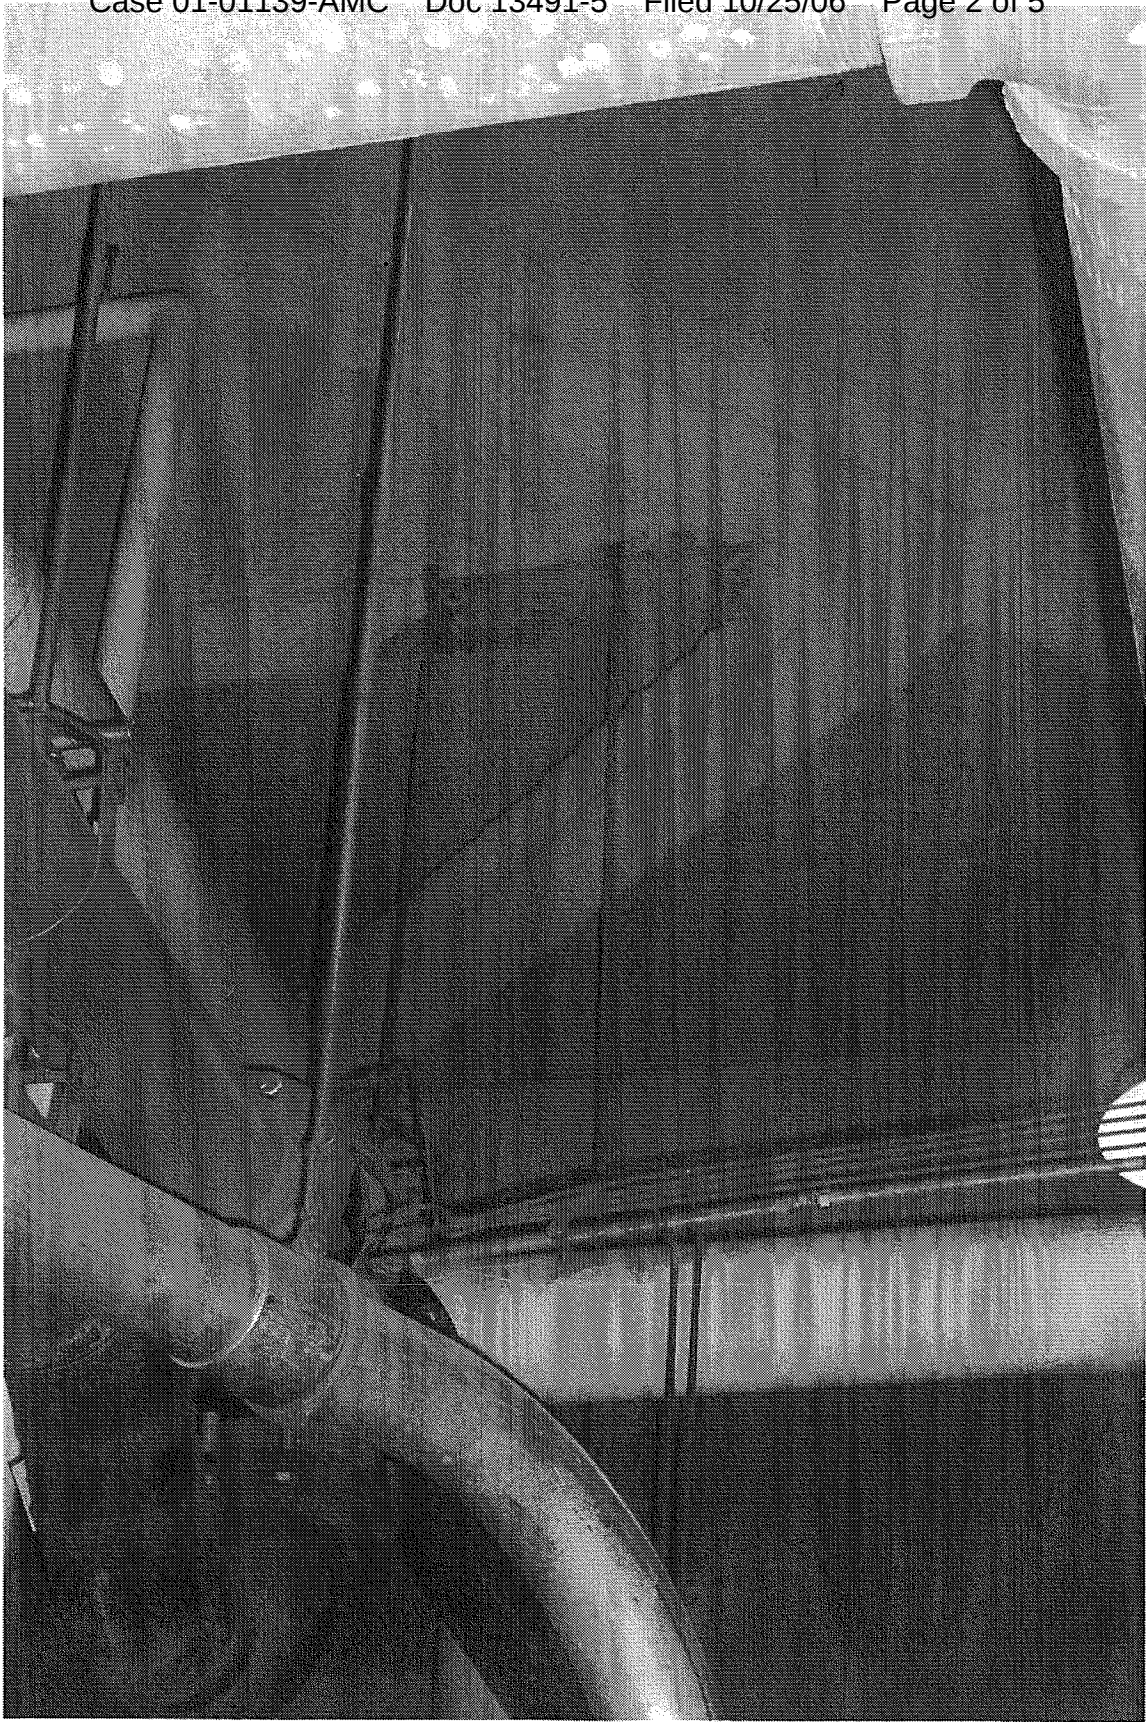
36. B Floor East Mech Rm - General view of delaminated fireproofing off beam in mechanical room

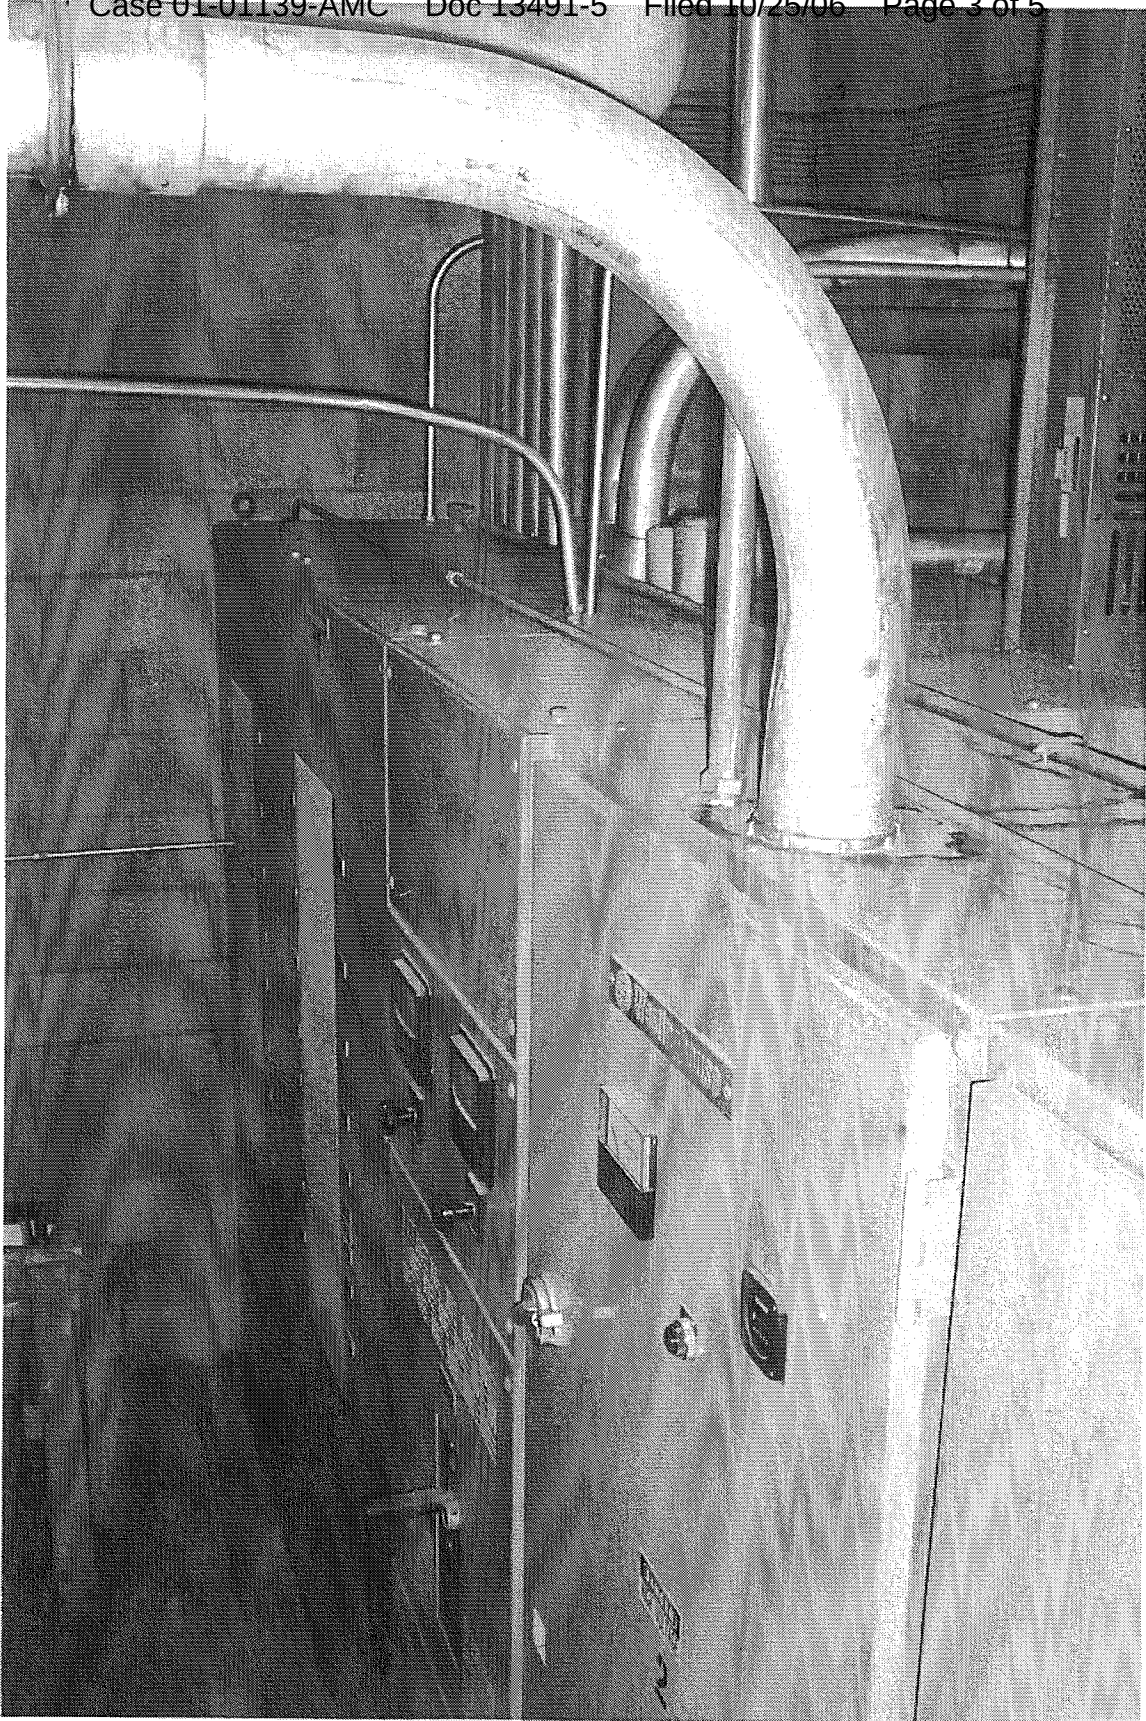
37. B Floor East Mech Rm - General view of fireproofing debris on top of large electrical panel

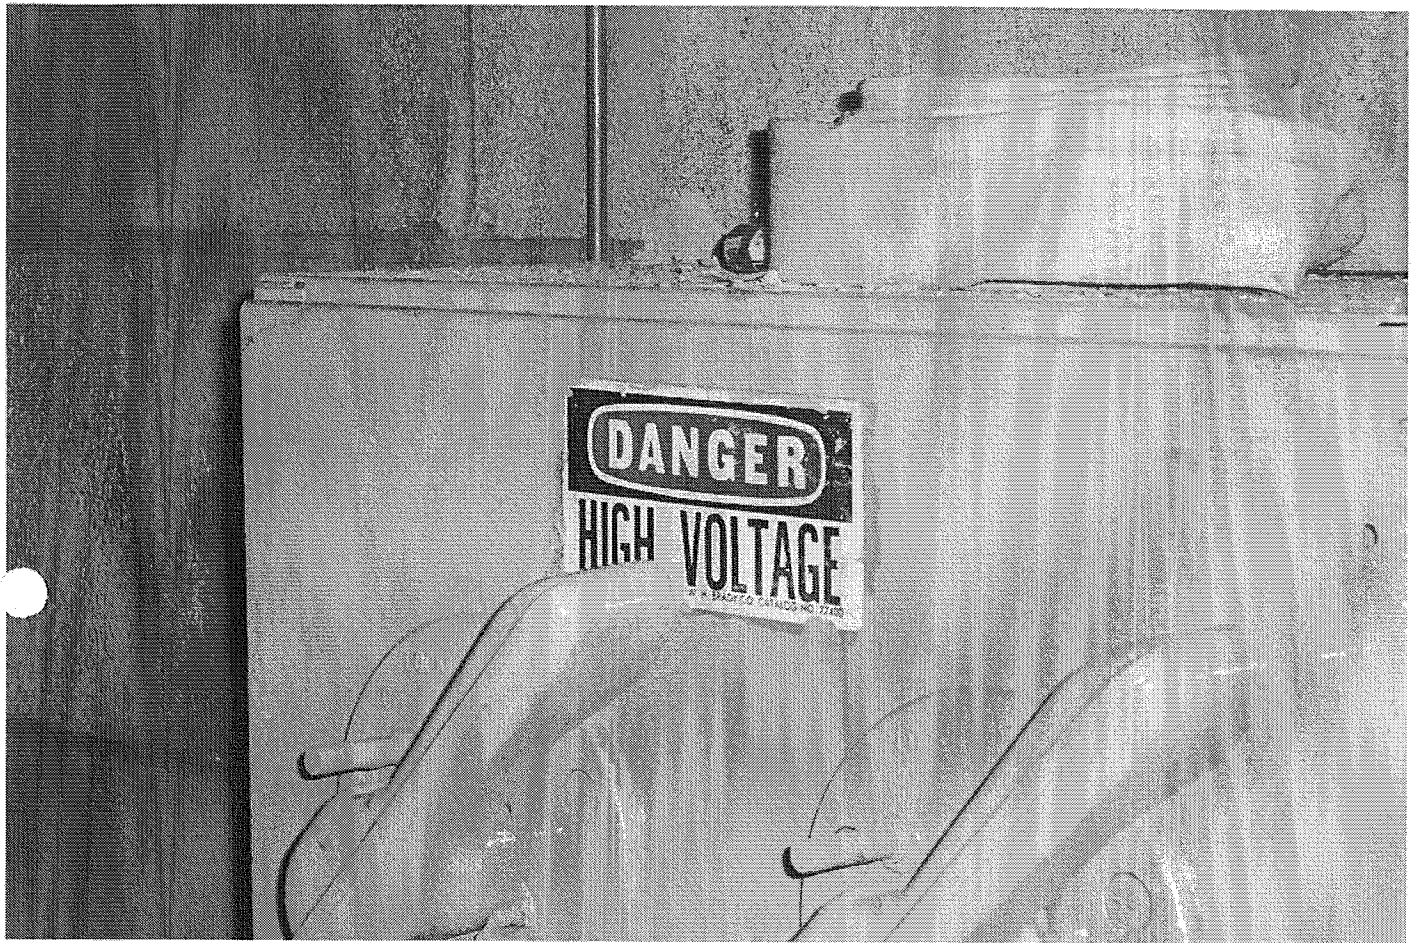
39. B Floor East Mech Rm - View of fireproofing debris on top of breaker box
